Prüfbericht - Nr.: 19617002 001 <i>Test Report No.:</i>		Seite 1 von 24 <i>Page 1 of 24</i>	
Auftraggeber: <i>Client:</i>	Diamond Systems Corporation 158 Commercial Street Sunnyvale CA 94086, USA		
Gegenstand der Prüfung: <i>Test item:</i>	EPS-12000-CM 12-port gigabit Ethernet switch within Sabre enclosure		
Bezeichnung: <i>Identification:</i>	SabreNet 12000	Serien-Nr.: <i>Serial No.:</i>	D885148
Wareneingangs-Nr.: <i>Receipt No.:</i>	1803373721	Eingangsdatum: <i>Date of receipt:</i>	2018.12.04
Prüfart: <i>Testing location:</i>	ENVITEST LABORATORIES PVT LTD No.14-1510, Shamanna Reddy Layout, Garvebhavi Palya, Hosur Road, Bangalore – 560068		
Prüfgrundlage: <i>Test specification:</i>	As per customer specification w.r.t MIL-STD-810G w/Change 1		
Prüfresultat: <i>Test Result:</i>	Refer section " Summary of testing"		
Prüflaboratorium: <i>Testing Laboratory:</i>	TÜV Rheinland (India) Pvt. Ltd. 27/B, 2nd Cross Road, Electronic City Phase-1 Bangalore- 560100

TEST REPORT ENVIRONMENTAL TESTING

Test item description : EPS-12000-CM 12-port gigabit Ethernet switch within Sabre enclosure

All the test was conducted as per customer specification w.r.t MIL-STD-810G w/Change 1

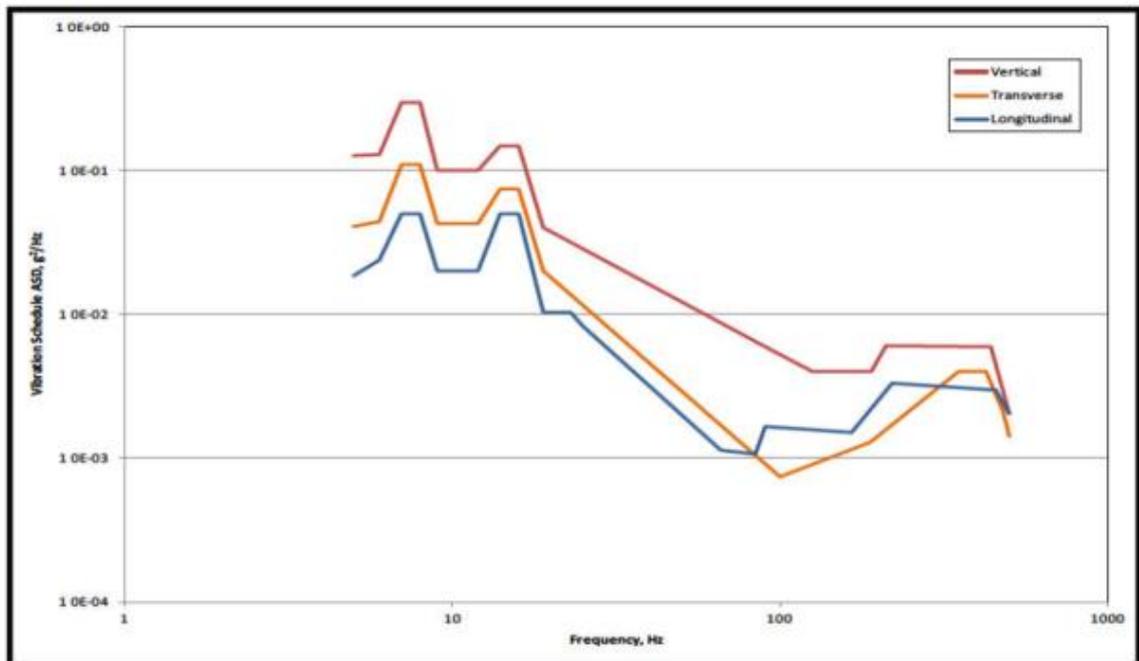
Figure 514.7C-4. – Category 4 – Composite wheeled vehicle vibration exposure.

Table 514.7C-V. Category – 4 – Composite wheeled vehicle vibration exposure. (Break points for curves of Figure 514.7C-4.)

1. Composite Wheeled Vehicle Vibration Exposure:- Test was performed in Functional state.

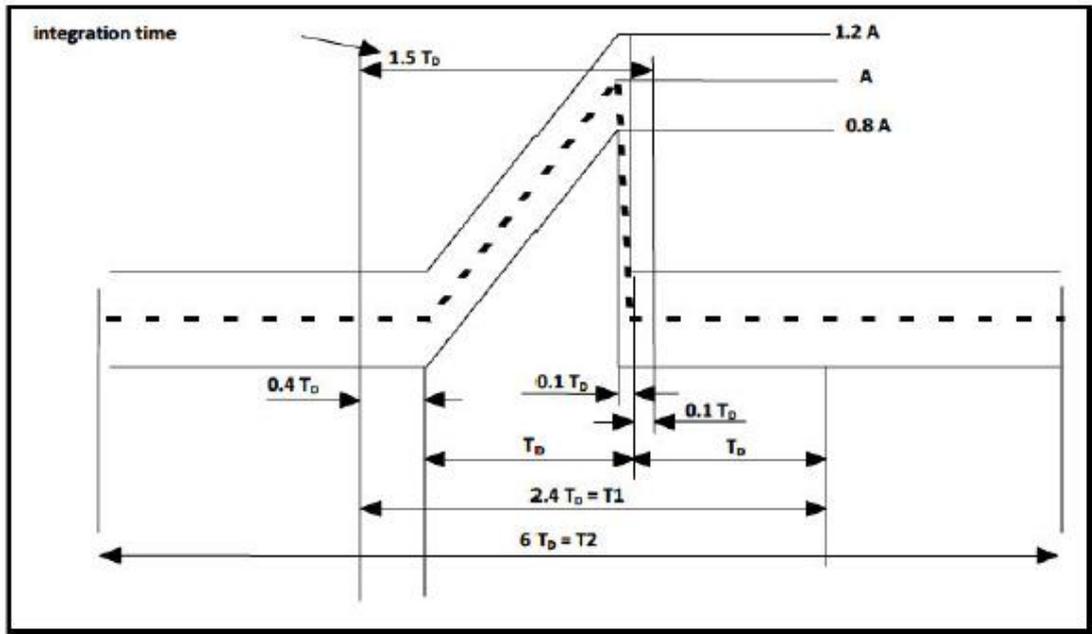
Figure 516.7-10. Terminal peak sawtooth shock pulse configuration and its tolerance limits (for use when shock response spectrum analysis capability is not available in conduct of Procedures I, II, and V).

- a. Functional Shock Test :- As per customer requirement w.r.t MIL-STD-810G, Method 516.7, Procedure I:
 - i. Test Specification :- 40G 11ms, Waveform:- Terminal Peak Sawtooth, Number of shocks:- 3 (Positive and negative), Total Shocks:- 18
- b. Crash Hazard Shock Test :- As per customer requirement w.r.t MIL-STD-810G, Method 516.7, Procedure V :
 - i. Test Specification :- 75G 6ms, Waveform:- Terminal Peak Sawtooth, Number of shocks:- 2 (Positive and negative), Total Shocks:- 12

Table 516.7-IV. Terminal peak sawtooth default test parameters for Procedures I -Functional Test, and Procedure V – Crash Hazard (refer to Figure 516.7-10).

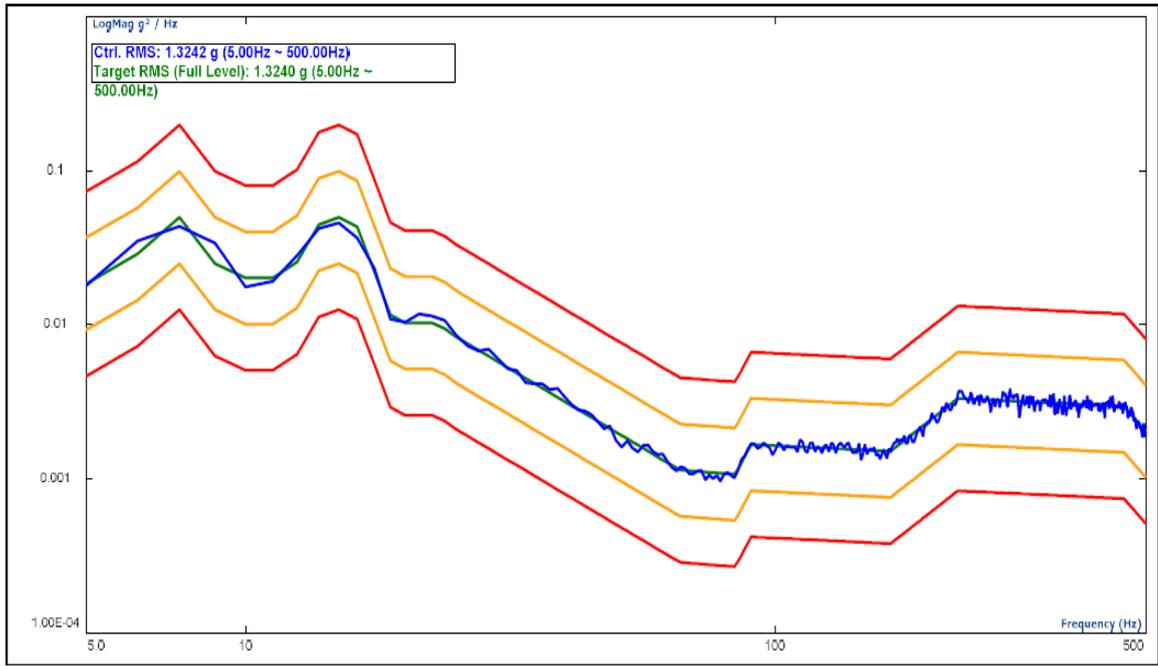
XX -Axis

1.4	Test Graphs		
-----	-------------	--	--

Clause	Requirement + Test	Result - Remark	Verdict
1	Random Vibration Test		P
1.1	Pre-checks		P
	Physical checks	No physical damages observed before Vibration test.	P
	Functional checks	All the Functional check was performed by customer and witnessed by TÜVR and EUT was working fine before start of the test.	P
1.2	Random Vibration test - Test Requirement		
	Test Specification	Refer summary of testing	-
	Operation condition	ON	-
	Duration	40 min/ axis	-
	No. of Axis	XX, YY & ZZ	-
1.3	Post check:		P
	Physical checks	No physical damages observed after Random Vibration test.	P
	Functional checks	All the Functional check was performed by customer and witnessed by TÜVR (See attachment – 2) and EUT was working fine after Random test.	P

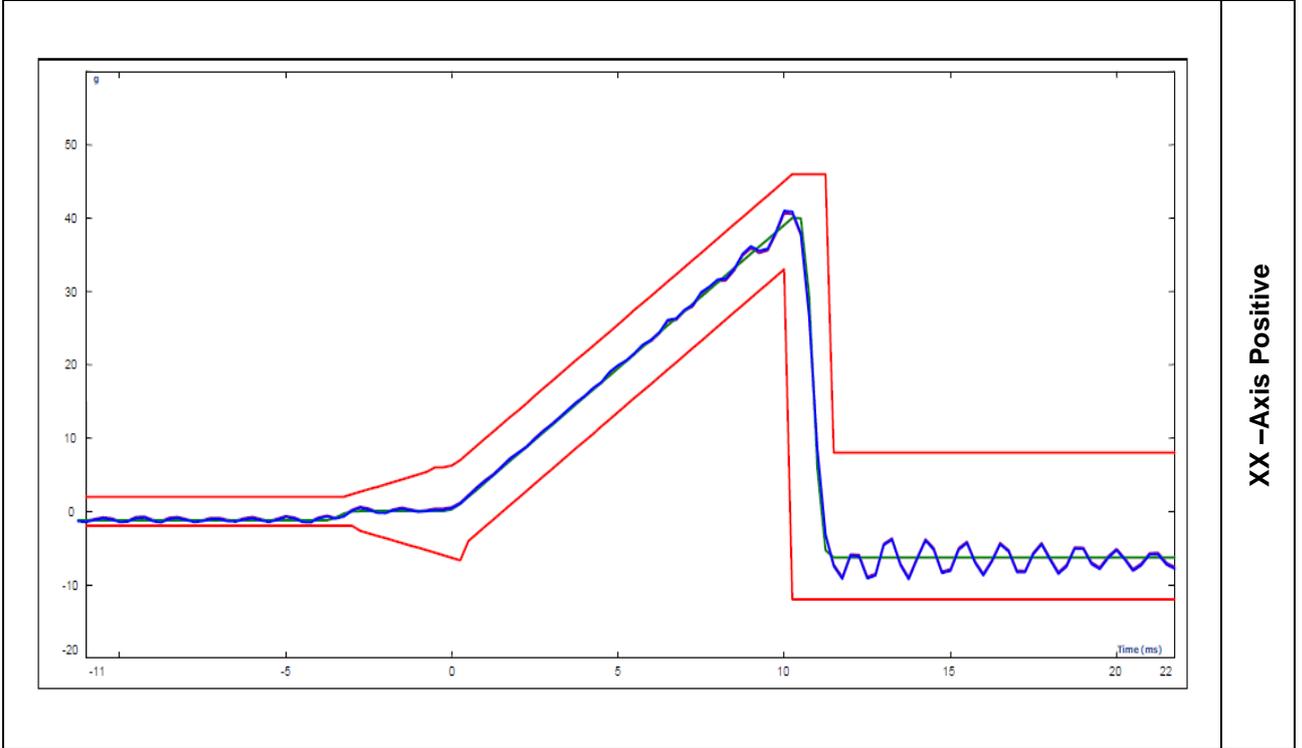
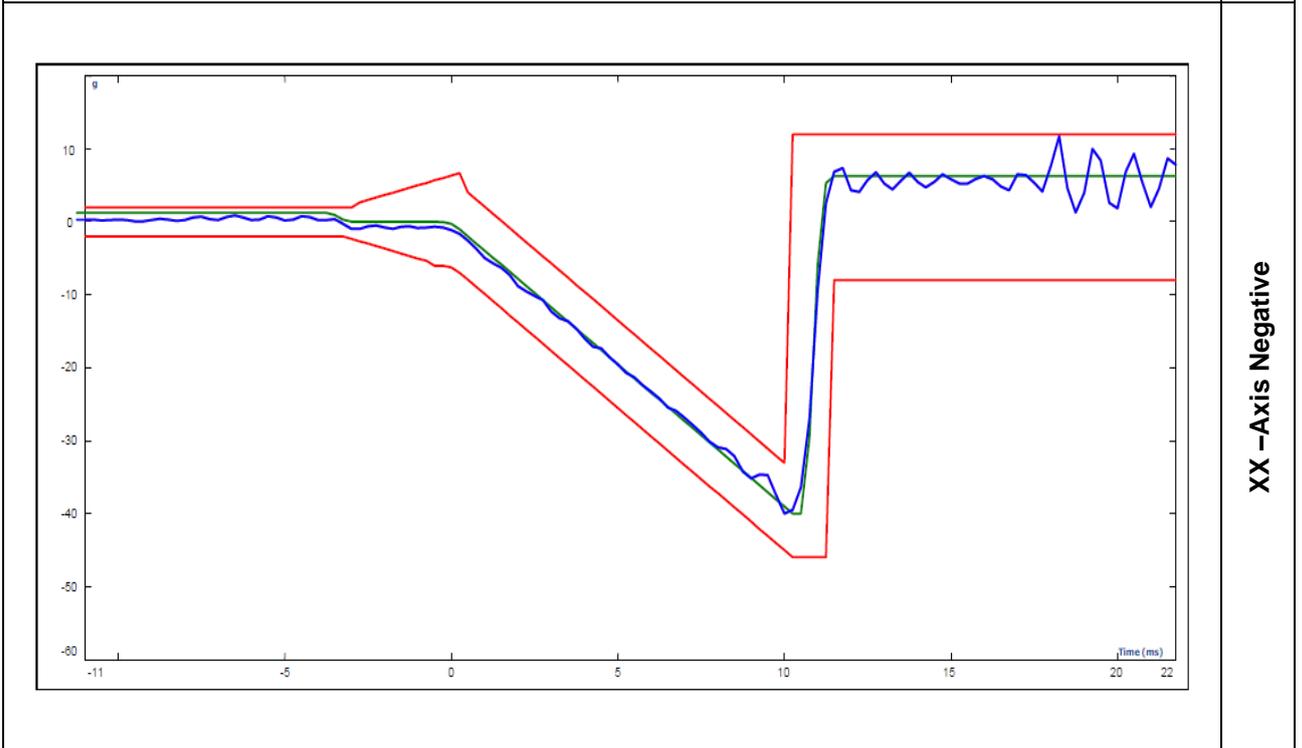
2.4	Test Graphs		
-----	-------------	--	--

Environmental Tests			
Clause	Requirement + Test	Result - Remark	Verdict
2	Functional Shock Test		P
2.1	Pre-checks		P
	Physical checks	No physical damages observed before Shock test.	P
	Functional checks	All the Functional check was performed by customer and witnessed by TÜVR and EUT was working fine before Shock test.	P
2.2	Functional Shock Test - Test Requirement		
	Waveform	Terminal Peak Sawtooth	-
	Test Specification	Shock Level	-
		Shock Duration	
		40 g	11 ms
	Operation Condition	ON	-
	No. of Axis	X, Y & Z	-
	No. of Shocks	18	-
2.3	Post check:		P
	Physical checks	No physical damages observed after Shock test.	P
	Functional checks	All the Functional check was performed by customer and witnessed by TÜVR (See attachment – 2) and EUT was working fine after Shock test.	P

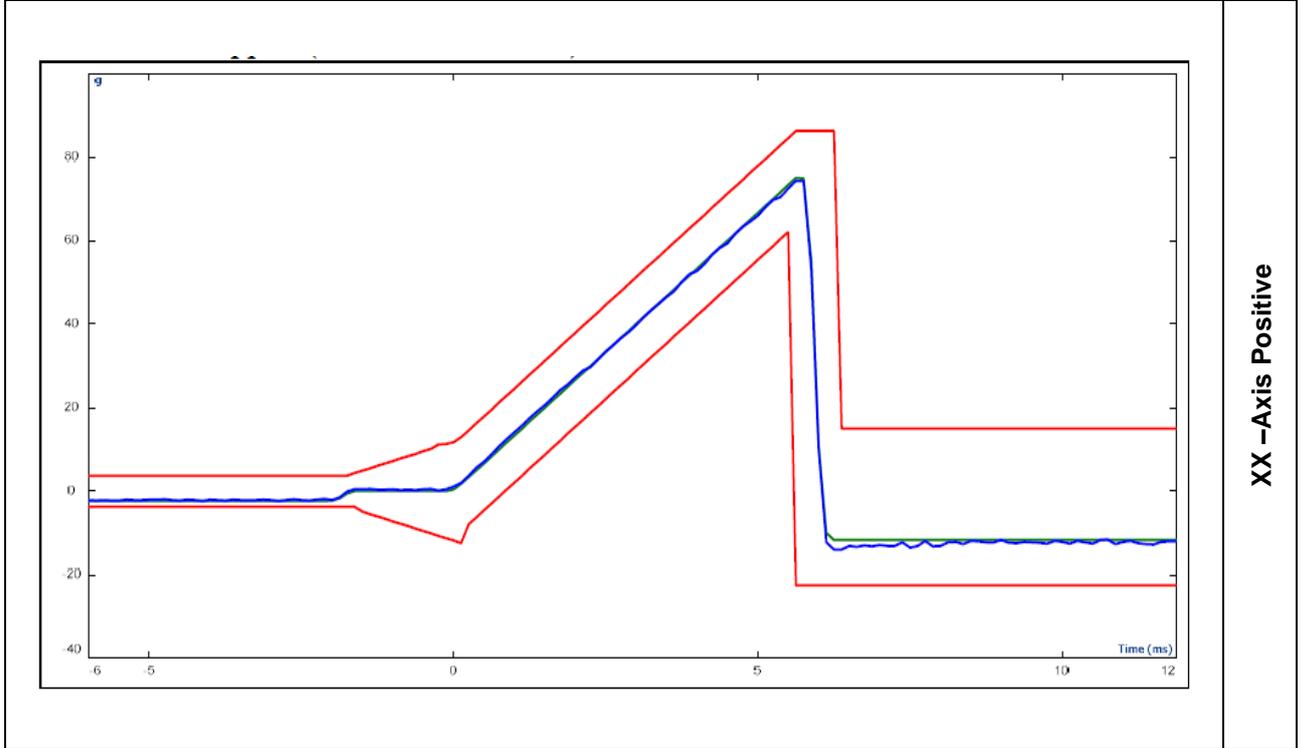
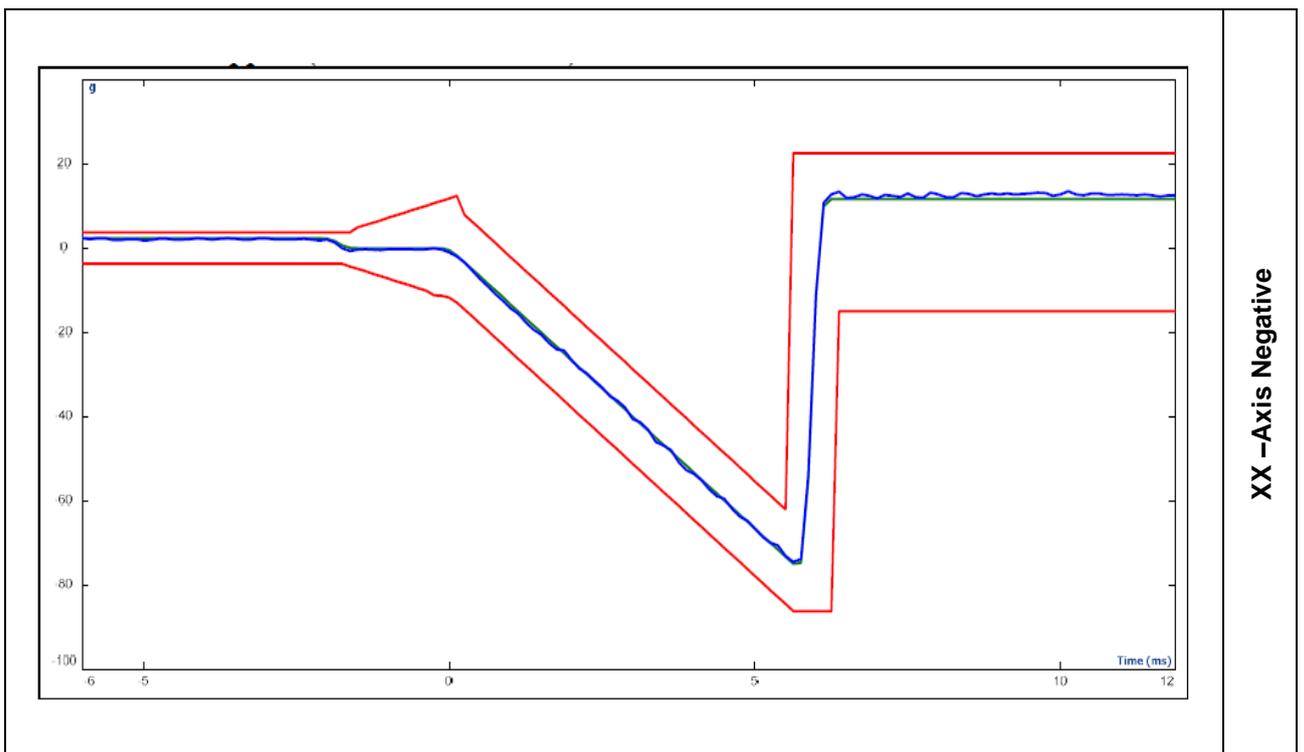
3.4	Test Graphs		
-----	-------------	--	--

Environmental Tests			
Clause	Requirement + Test	Result - Remark	Verdict
3	Crash Hazard Shock Test		P
3.1	Pre-checks		P
	Physical checks	No physical damages observed before Shock test.	P
	Functional checks	All the Functional check was performed by customer and witnessed by TÜVR and EUT was working fine before Shock test.	P
3.2	Crash Hazard Shock Test - Test Requirement		
	Waveform	Terminal Peak Sawtooth	-
	Test Specification	Shock Level	-
		Shock Duration	
		75 g	6 ms
	Operation Condition	OFF	-
	No. of Axis	X, Y & Z	-
	No. of Shocks	12	-
3.3	Post check:		P
	Physical checks	No physical damages observed after Shock test.	P
	Functional checks	All the Functional check was performed by customer and witnessed by TÜVR (See attachment – 2) and EUT was working fine after Shock test.	P
